Cracked Platform Pivot Plate Example

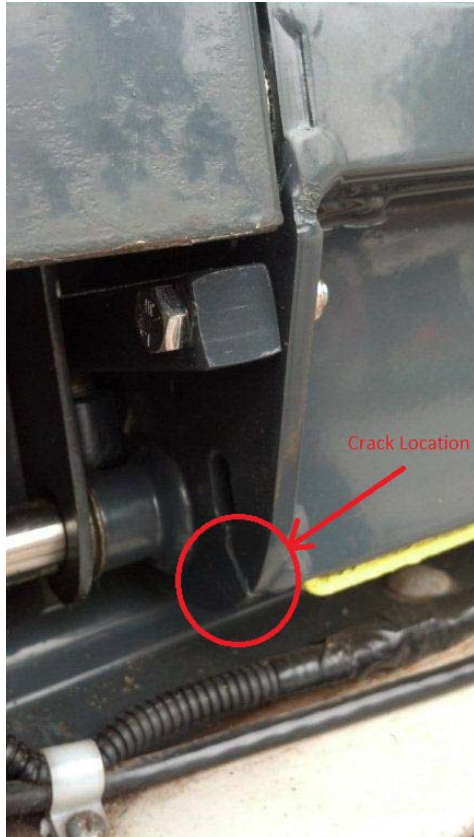
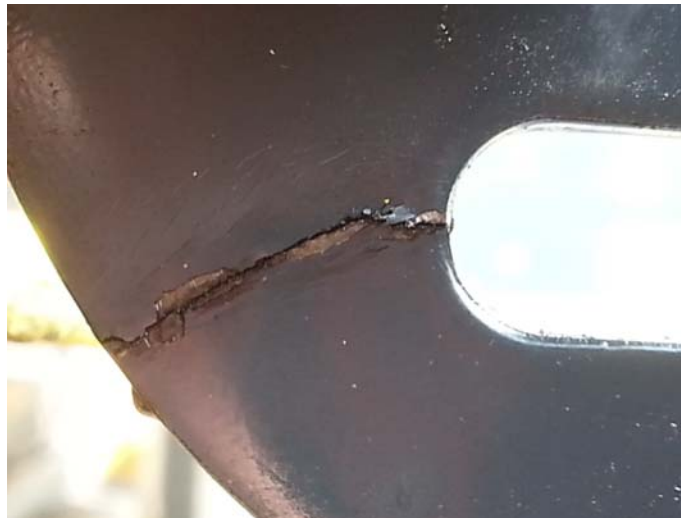
Under certain conditions the side plate of the larger platforms included on the subject S-Series model wheelchair lifts can exhibit cracking while in the stowed position which, if left unchecked can propagate to the point where separation of the rear portion of the side plate occurs rendering the lift inoperable and possibly unsafe to use.

The cracking as illustrated has been observed on less than 5% of the subject population and appears to be caused by a combination of factors including but not necessarily limited to, incomplete stowing of the lift and/or maladjustment or otherwise malfunctioning of the stow lock device combined with a violent side- to- side movement that might be associated with traversing curbs, speed bumps and other variable road conditions, especially at higher speeds.
