SERVICE BULLETIN

Subject:BUS KNEEL HEIGHTApplicable Products:SSR Series Products

Effectivity: 01/19/23

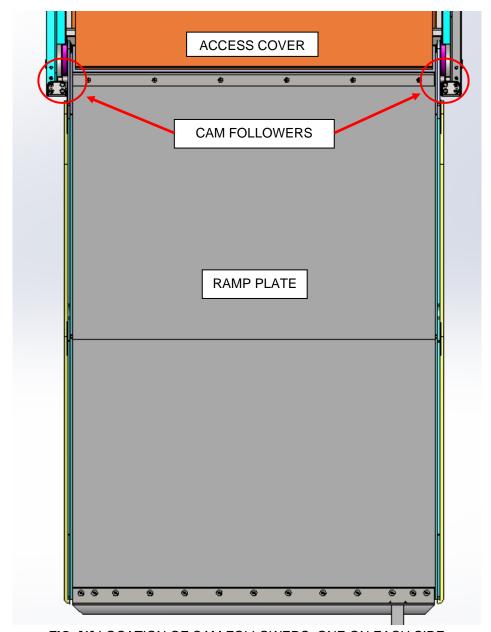
FIG. [1] LOCATION OF CAM FOLLOWERS. ONE ON EACH SIDE

Operators must be trained to kneel the bus to lower the bus floor height when deploying the ramps to ground level. To prevent damage to the ramp plate cam followers, kneel the bus every time the ramp is deployed to ground on vehicles with a ride height greater than 12". Inspect and replace the cam followers if damage is observed.

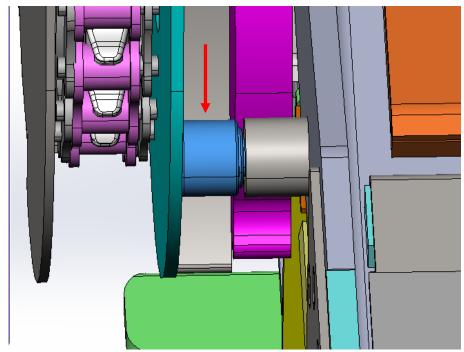
FIG. [2] CLOSE UP OF LEFT SIDE CAM FOLLOWER

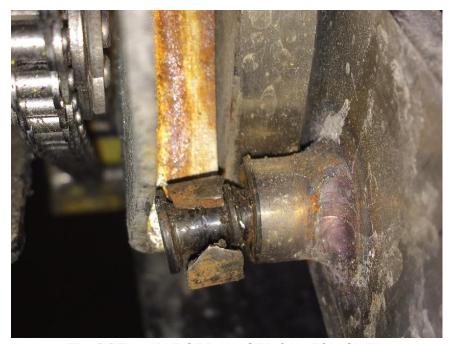
SSR ramps have a max. floor height application of 12" to remain compliant with FMVSS and ADA slope requirements when deployed to ground. In applications where the ramp is deployed to the ground and the bus floor height is greater than 12", the bus needs to be knelt so that the bus floor height is 12" or less. Deploying the ramp to ground at a floor height greater than 12" may damage the cam followers if the ramp is loaded with a passenger.

Failure of the cam followers may include; breakage, separation, or fracture of the bearing surface, bending of the mounting studs, and shearing of the cam follower shaft. Failure of the cam followers can also affect the operation of the ramp and damage other mechanical components.

FIG. [3] EXAMPLE OF DAMAGED CAM FOLLOWER
